Internal erosion under spillway rested on an embankment dam

Abstract

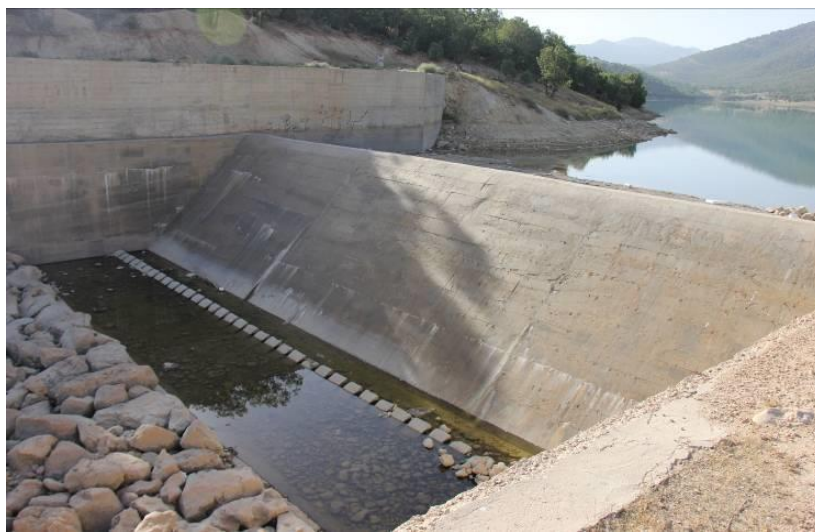
Fig. 1. a) Ogee spillway of Shahghasem dam

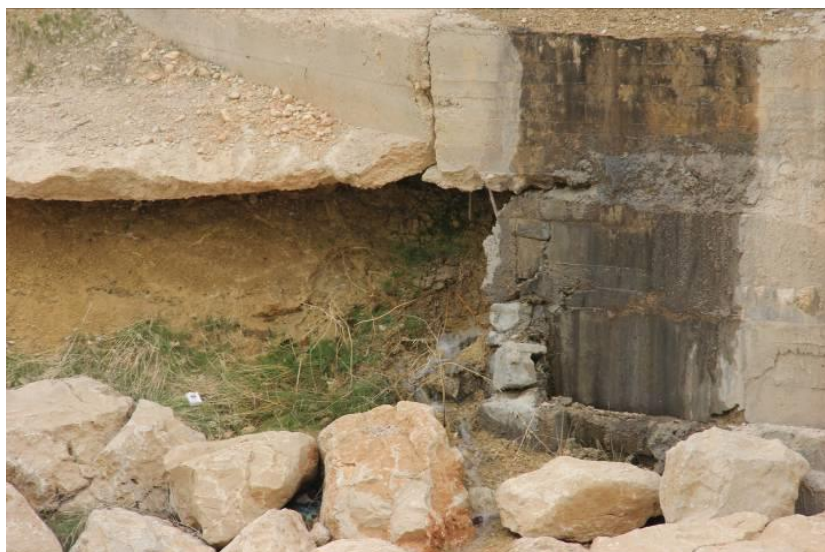
Fig. 1. b) Piping hole and seeping flow between abutment and concrete body at downstream

Looking at design reports and as-built maps indicated that there was no sufficient watertight barrier between the concrete structure and the abutment or the embankment and also downstream filter to plug eroded particles. With respect to time, expanding of the hole was significant. The main point during flood periods is that the seeping flow was clear water. There was no remedial or safety measure to control this phenomena. Up

In Figure 1b, it can be observed that there is a longitudinal hole along with side wall of spillway which is going to expand more and more. Field observation has indicated that maximum flow rate seeped along hole is about 8 liters per second. This value may be dangerous for stability of the spillway.

The best case is an integrated approach to control internal erosion as well as piping. The first part is to attach a concrete wall to the main wall provided that the Lane's criterion is satisfied (Fig. 6). The second remedial action is to fill the hole pipe with concrete and cement.

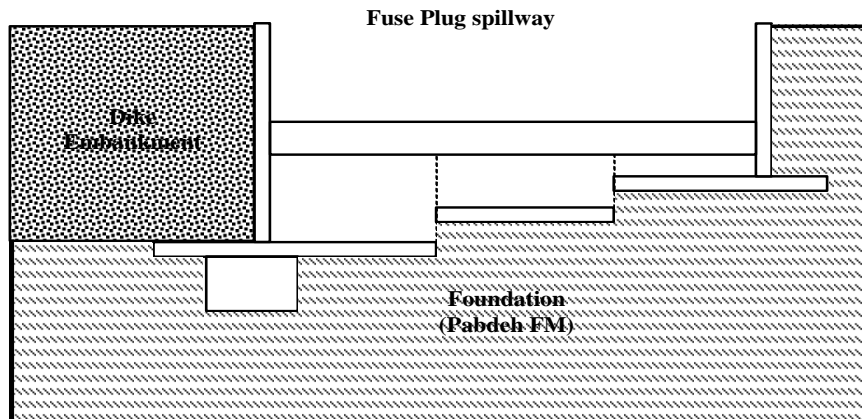
occurred in the right abutment (Fig. 1). Based on the geology of the dam site, in this part the predominant foundation material is marl which contains limestone with fine and homogenous grain size (Fig. 2). The main point is that the cohesion of such material is low, and therefore this material is erodible. It is observed that all the materials are Pabdeh Gurpi formation which is an impermeable formation with very low cohesion. Marlstone is the typical rock of the Pabdeh Gurpi formation.

Fig. 2. a) Cross section of spillway and its foundation

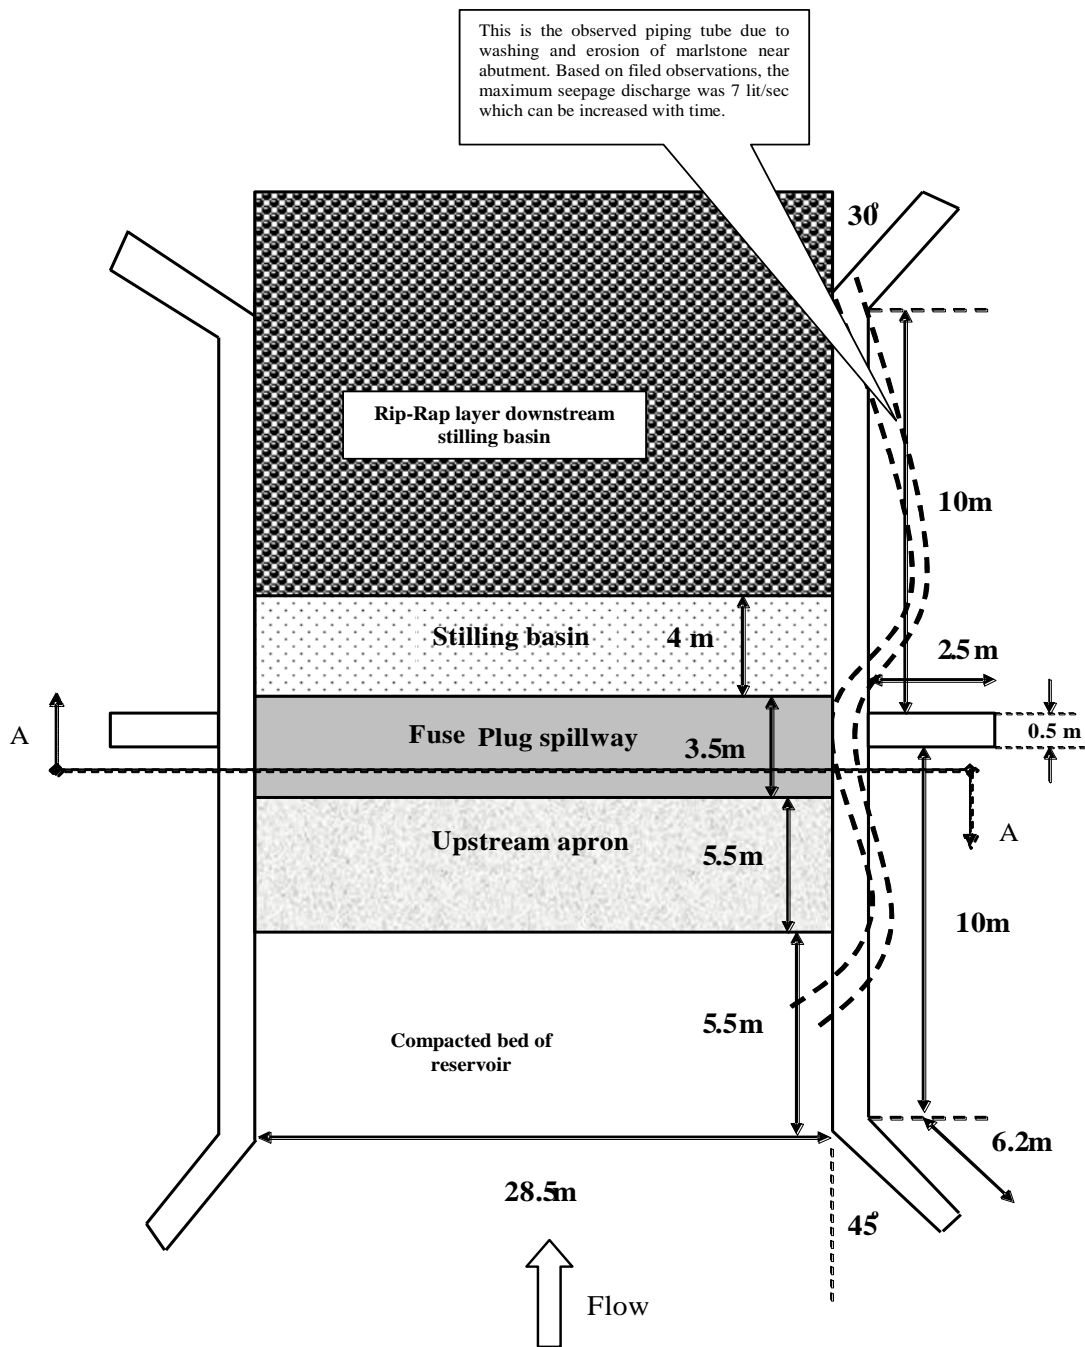
Fig. 3. a) Plan view of fuse plug spillway of Shahghasem dam (the dashed tube is piping hole)

It is necessary to look at as-built maps for finding the cause of this inappropriate design (Figs. 3a and 3b). It is observed that there are not enough watertight barriers between the concrete structure and the abutment or the embankment. First criterion in hydraulic engineering to safety design a hydraulic structure against piping is Lane and Bligh's creeping factor. By considering this simple formula, it can keep away from these destructive phenomena. Unfortunately in design maps and reports of the dam, there is no sign to consider these criteria. The main parameters in Lane's creeping factor are head difference between upstream and downstream (Δh) and creeping length of seeping water along with spillway (L). Based on the dimensions of the wall and creeping length, Δh and L were determined by using as-built maps as 6 and 15m respectively. The lane's criterion C was computed 2.5 using inverse method which is quite less than recommended by Lane (1934). The recommended value for

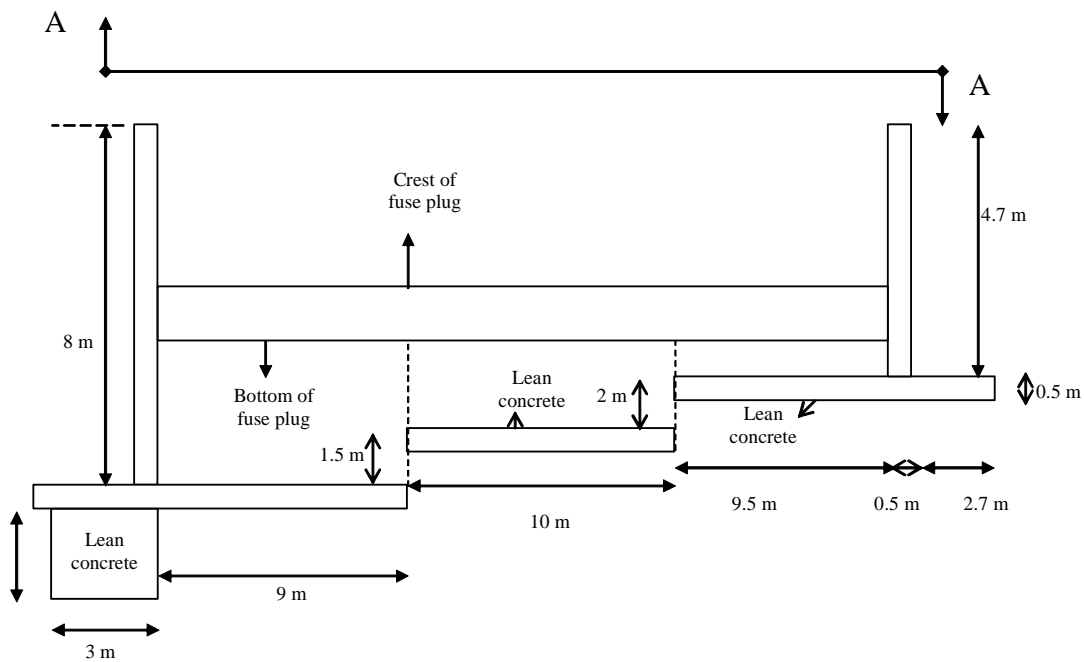
Fig. 3. b) Front view of fuse plug spillway of Shahghasem dam (not to scale)
