## **Internal erosion under spillway rested on an embankment dam**

In this paper we investigate the mechanism of internal erosion caused in the right abutment of the Shahghasem dam's spillway. Shahghasem dam is an earthen dam located in Yasouj, in southwest of Iran. A significant hole and pipe have been observed in the corner of the right abutment from upstream view. The foundation is Marlstone, which has low cohesion and susceptible for internal erosion and piping in some conditions. Going through details of the design maps has shown that Lane's criteria for selecting safe dimensions of the seepage control measures have not been considered properly. A series of the supportive walls are designed to attach to the right part of the spillway in order to increase the length of seepage. The pipe route of the erosion should also be grouted with high quality concrete.

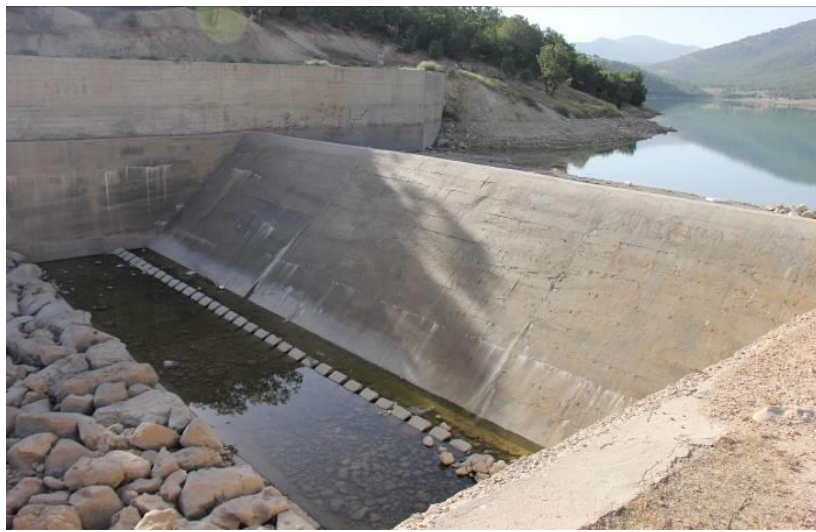
Shahghasem dam, located in Shahghasem valley, south of Yasouj, southwest of Iran, consists of an earth-embankment, 250 meters long and 47.2 meters high, over Marlstone as it is shown in Figure 1a. This dam has a lateral spillway near the right abutment.

**Fig. 1. a) Ogee spillway of Shahghasem dam**

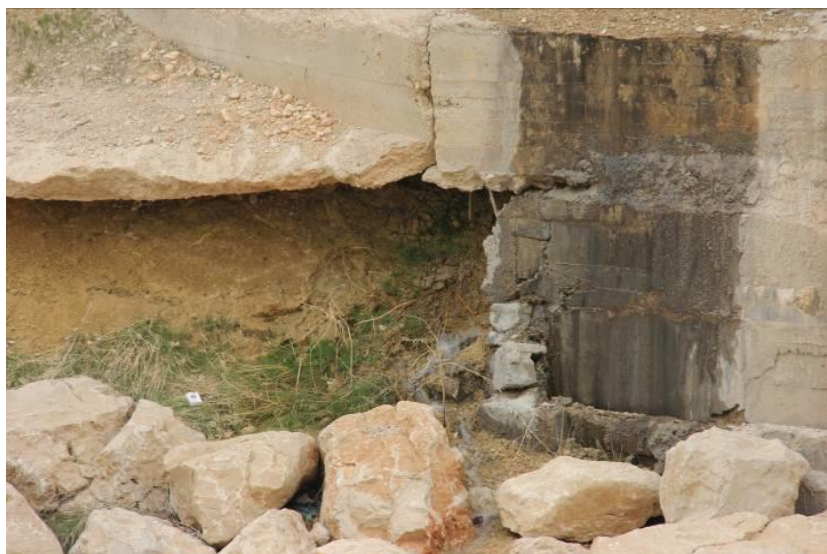
**Fig. 1. b) Piping hole and seeping flow between abutment and concrete body at downstream**

Looking at design reports and as-built maps indicated that there was no sufficient watertight barrier between the concrete structure and the abutment or the embankment and also downstream filter to plug eroded particles. With respect to time, expanding of the hole was significant. The main point during flood periods is that the seeping flow was clear water. There was no remedial or safety measure to control this phenomena. Up

In Figure 1b, it can be observed that there is a longitudinal hole along with side wall of spillway which is going to expand more and more. Field observation has indicated that maximum flow rate seeped along hole is about 8 liters per second. This value may be dangerous for stability of the spillway.

The best case is an integrated approach to control internal erosion as well as piping. The first part is to attach a concrete wall to the main wall provided that the Lane's criterion is satisfied (Fig. 6). The second remedial action is to fill the hole pipe with concrete and cement.

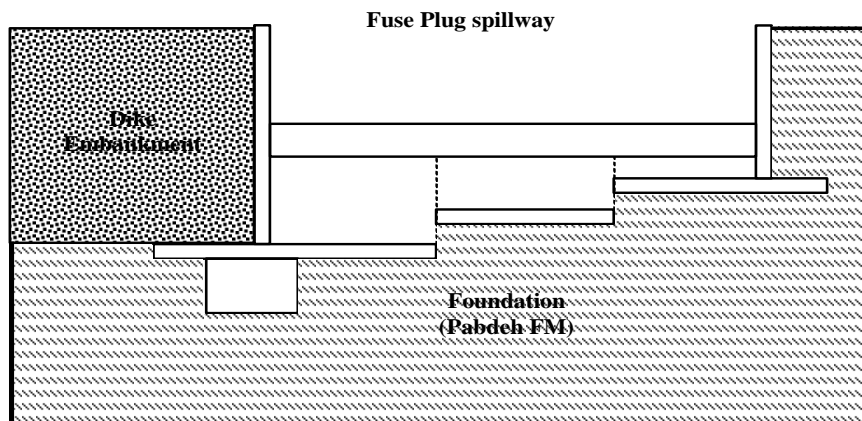
occurred in the right abutment (Fig. 1). Based on the geology of the dam site, in this part the predominant foundation material is marl which contains limestone with fine and homogenous grain size (Fig. 2). The main point is that the cohesion of such material is low, and therefore this material is erodible. It is observed that all the materials are Pabdeh Gurpi formation which is an impermeable formation with very low cohesion. Marlstone is the typical rock of the Pabdeh Gurpi formation.

Fig. 2. a) Cross section of spillway and its foundation

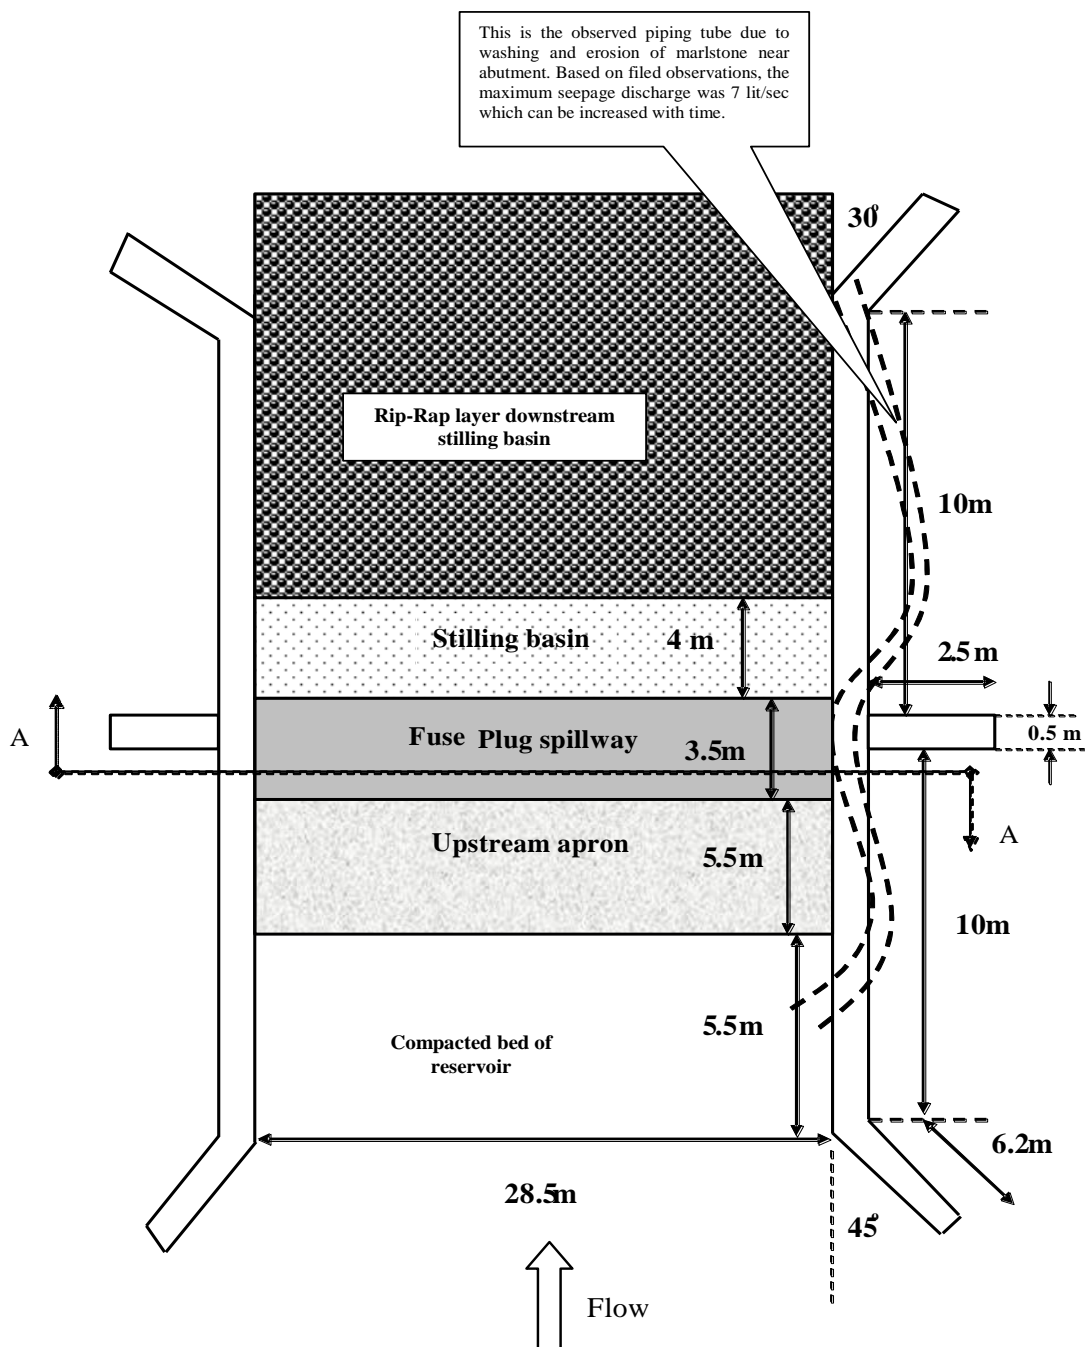
Fig. 3. a) Plan view of fuse plug spillway of Shahghasem dam (the dashed tube is piping hole)

It is necessary to look at as-built maps for finding the cause of this inappropriate design (Figs. 3a and 3b). It is observed that there are not enough watertight barriers between the concrete structure and the abutment or the embankment. First criterion in hydraulic engineering to safety design a hydraulic structure against piping is Lane and Bligh's creeping factor. By considering this simple formula, it can keep away from these destructive phenomena. Unfortunately in design maps and reports of the dam, there is no sign to consider these criteria. The main parameters in Lane's creeping factor are head difference between upstream and downstream ( $\Delta h$ ) and creeping length of seeping water along with spillway ( $L$ ). Based on the dimensions of the weir and creeping length,  $\Delta h$  and  $L$  were determined by using as-built maps as 6 and 15m respectively. The lane's criterion  $C$  was computed 2.5 using inverse method which is quite less than recommended by Lane (1934). The recommended value for

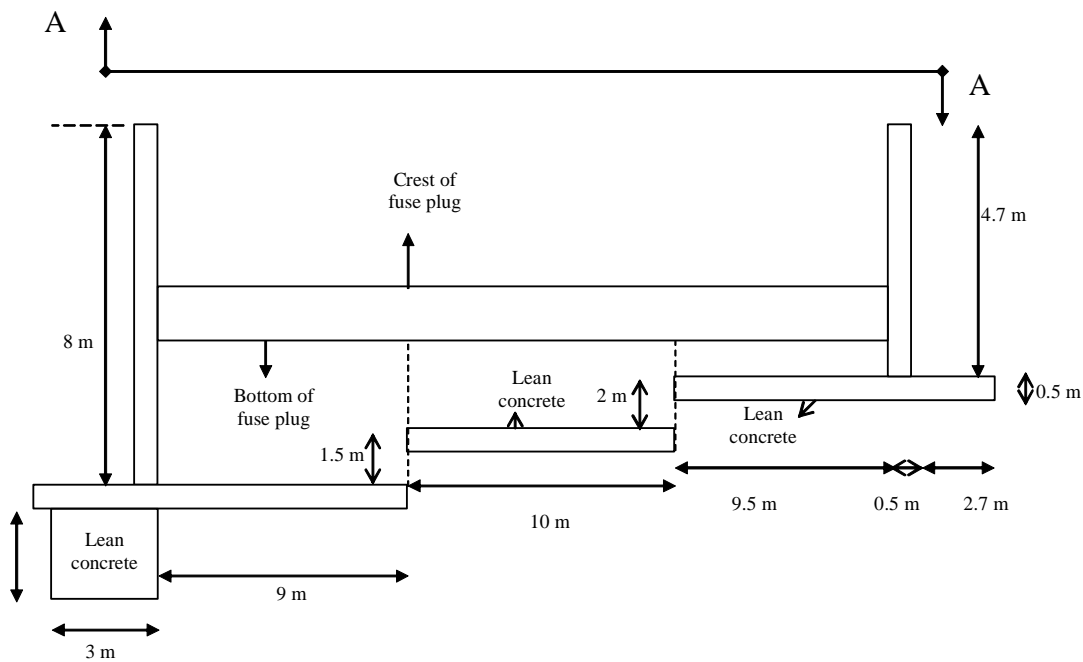
Fig. 3. b) Front view of fuse plug spillway of Shahghasem dam (not to scale)

In addition to above-mentioned reasons, there is another cause for occurring piping. This cause is asymmetry foundation of the spillway which affected flow path and its diversion to right side. If the right supportive wall as well as lateral wall normal to spillway has been installed in deeper depth, then the

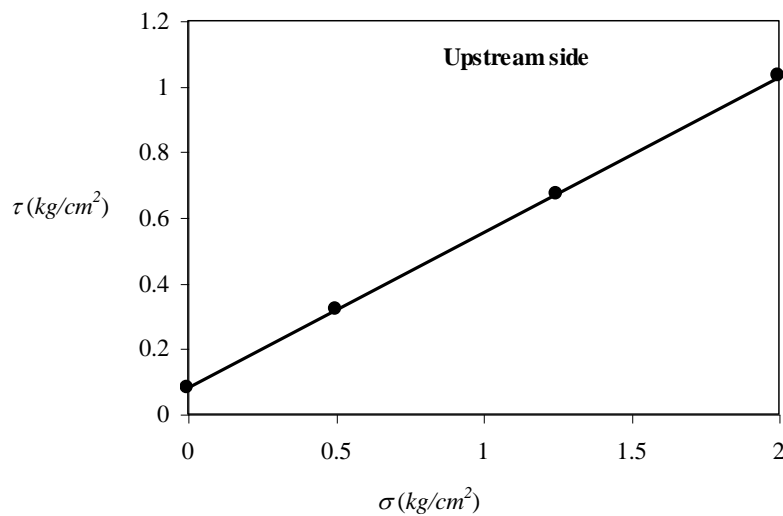
Fig. 4. a) Relationship between normal stress and shear stress of the upstream soil of abutment

$$\tau = 0.08 + \sigma \cdot \tan 29 \quad (3)$$

are low and internal friction angle is medium. Therefore the materials of abutment are categorized sensitive to erosion, because there is not enough cohesion between grains. Although the internal friction angle is not low but the low cohesion of two samples comparing to clayey soils have not been considered by design engineers. By saturating of the soil samples into water, all the grain

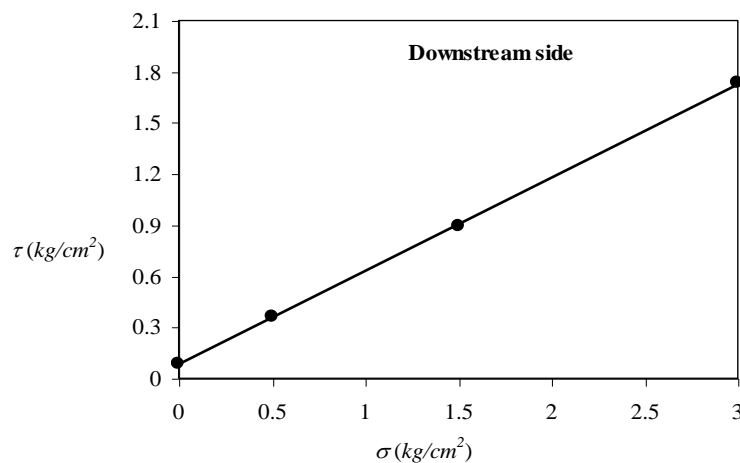
Fig. 4. b) Relationship between normal stress and shear stress of the downstream soil of abutment

$$\tau = 0.1 + \sigma \cdot \tan 25 \quad (4)$$

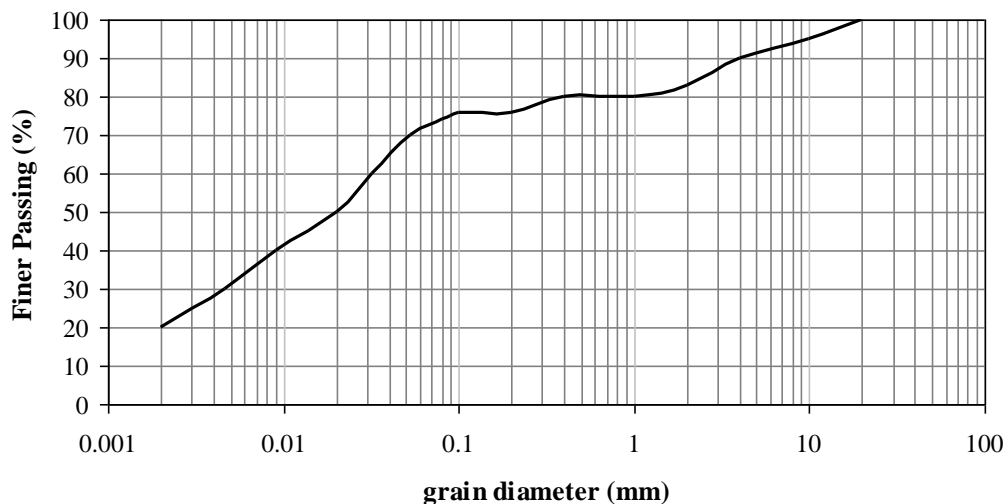
The mean diameter of the dispersed rock a grain is 0.02 which is quite low and based on the Unified methods is corresponded to silty soil. Also the gradation curve is not perfectly well-graded.

Fig. 5. Gradation curve of the materials of rock foundation

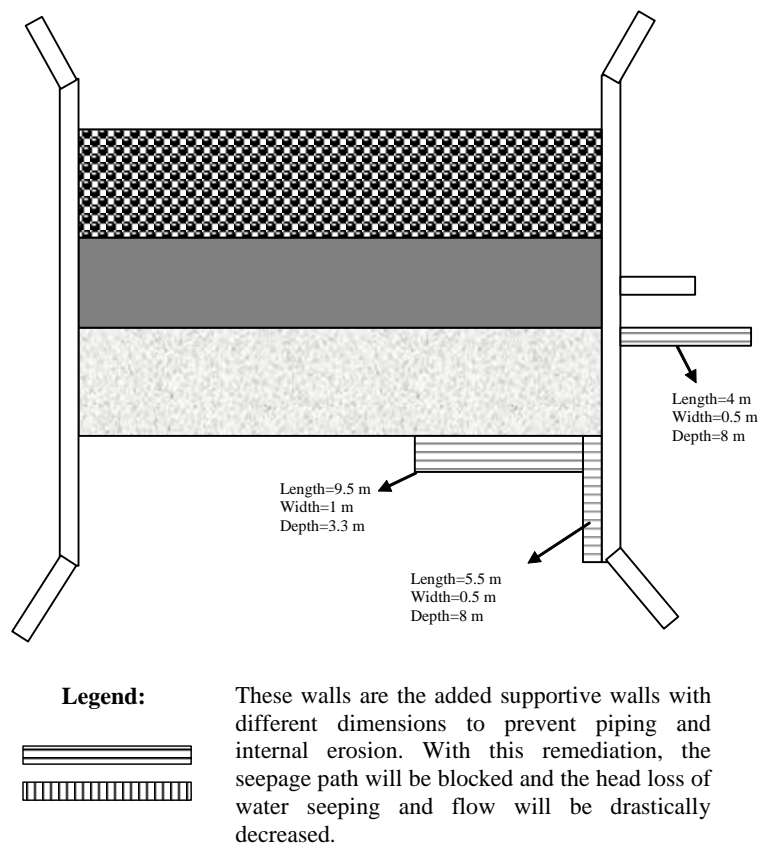
**Fig. 6. Final remedial measure to protect spillway against piping in right abutment**
