# Application of geophysical techniques to identify the causes of roadway instability in conductive ground (Fez region, Morocco)

Road instability in marly formations poses a major threat to infrastructure, as water saturation reduces soil-bearing capacity and promotes landslides and subsidence. To address this issue, this study applies an integrated geophysical approach combining electrical resistivity tomography (ERT) and the very low frequency electromagnetic (VLF-EM) method to identify the subsurface causes of pavement failures on three unstable road sections in the Fez-Meknes region (Morocco). Six ERT profiles were acquired along with VLF-EM surveys and subsequently validated by core drilling. The results reveal pronounced conductive anomalies extending to depths of approximately 15–20. These critical anomalies are characterized by very low resistivity values ( $\rho \approx 1\text{--}5 \Omega\cdot\text{m}$ ) and interpreted as water-saturated clayey-marly horizons. Moreover, VLF surveys delineate linear conductive zones, while ERT imaging highlights resistivity contrasts and their spatial distribution. Importantly, core drilling confirms that the most conductive zones ( $< 5

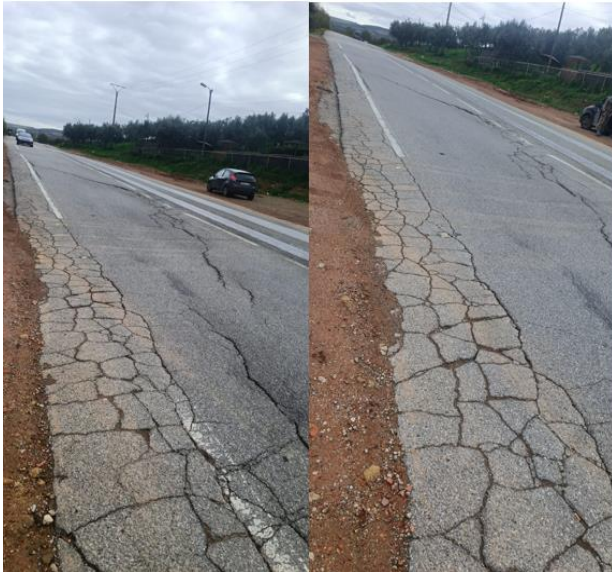
Figure 3. Pavement creep observed at the My Idriss site (N13 road).

The second site (My Idriss) is on the N13 national road, a few kilometers from Meknes toward My Idriss Zerhoun. It shows repeated damage, such as subsidence and surface slippage (creep, Figure 3).

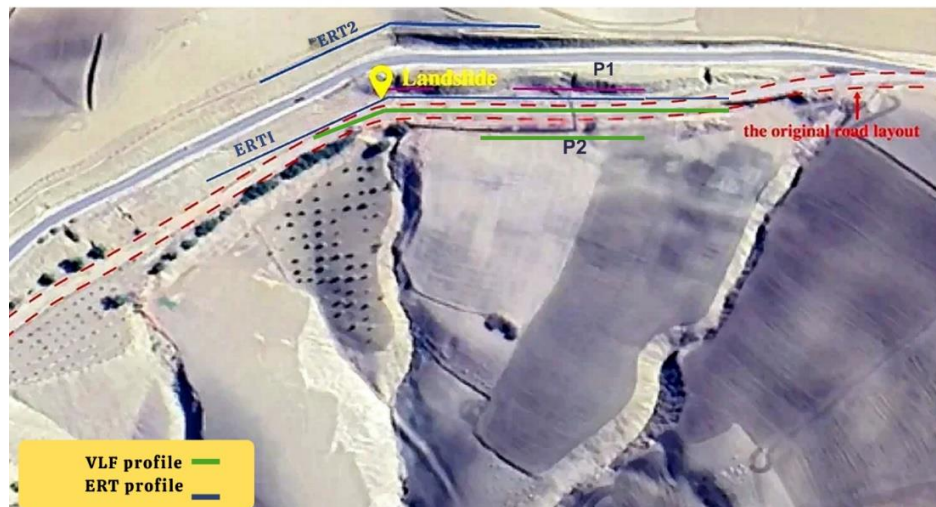
**Figure 4.** Aerial view of the My Yaacoub site showing the original road layout and VLF-ERT geophysical profile locations.

At the My Yaacoub site, two VLF profiles (P1: 250 m along the abandoned road section; P2: 100 m on the downslope embankment) and two ERT profiles (ERT1: 310 m along the abandoned section; ERT2: 155 m along the new alignment) were acquired (Figure 4).

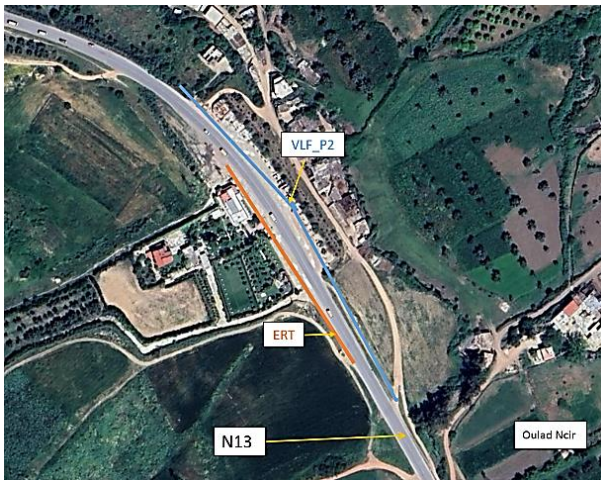
**Figure 8.** Aerial view of the My Idress site showing VLF-ERT geophysical profile locations.

The second site, designated My Idriss, is located on National Route 13, between Meknes and My Idriss Zerhoun, in Ouled Ncir. At this location, two very low frequency (VLF) profiles and one electrical resistivity tomography (ERT) profile were acquired (Figure 8).

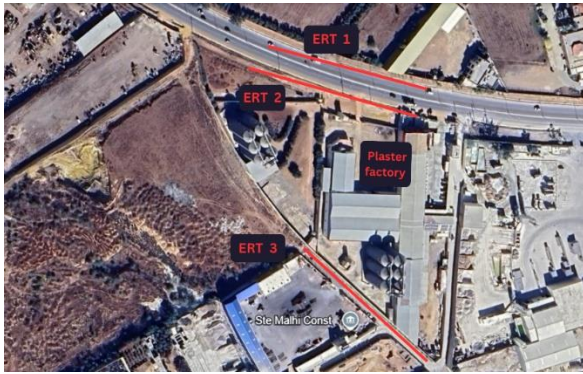
Figure 12. Aerial view of the RN6-Meknes site illustrating the ERT survey lines.

Three electrical resistivity tomography (ERT) profiles (Figure 12) were acquired parallel to the roadway: ERT1 and ERT2, on either side of the road, approximately 24 m apart laterally, and ERT3, approximately 150 m south of the section, with a slightly oblique orientation. It should be noted that ERT3 is far from the ditches; it was conducted on an unpaved street between the factories. In addition, two very low frequency (VLF) profiles were acquired. P1\_RN6 shares the same central point as ERT1, although their lengths differ (ERT1: 155 m; P1\_RN6: 200 m), while P2\_RN6 is co-located with the ERT3 profile. The objective is to identify preferential infiltration zones. The correlation between the VLF and ERT data is generally consistent. On the P1 profile (Figure 13), the VLF signal (P1\_RN6,  $x = 90$ –130 m) corresponds to a
