## **Internal erosion under spillway rested on an embankment dam**

In this paper we investigate the mechanism of internal erosion caused in the right abutment of the Shahghasem dam's spillway. Shahghasem dam is an earthen dam located in Yasouj, in southwest of Iran. A significant hole and pipe have been observed in the corner of the right abutment from upstream view. The foundation is Marlstone, which has low cohesion and susceptible for internal erosion and piping in some conditions. Going through details of the design maps has shown that Lane's criteria for selecting safe dimensions of the seepage control measures have not been considered properly. A series of the supportive walls are designed to attach to the right part of the spillway in order to increase the length of seepage. The pipe route of the erosion should also be grouted with high quality concrete.

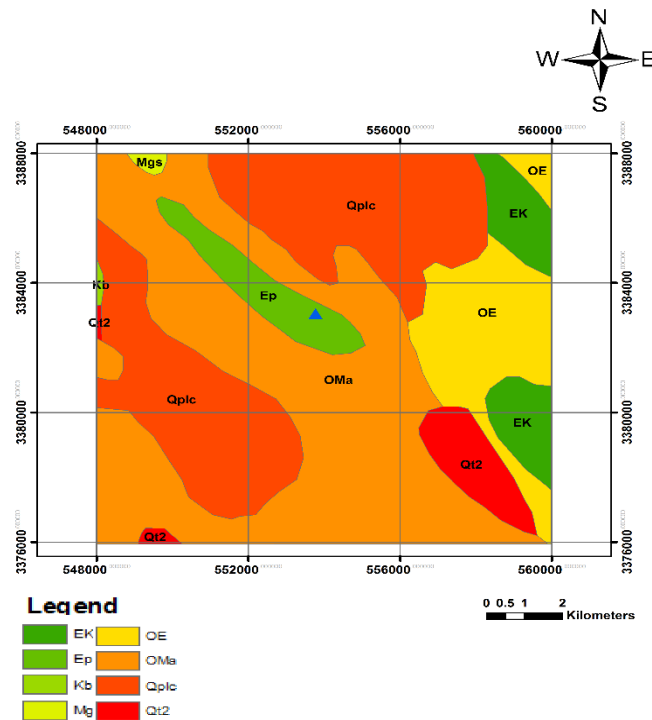
Fig. 2. b) Geological map of dam location with scale of 1:100000

occurred in the right abutment (Fig. 1). Based on the geology of the dam site, in this part the predominant foundation material is marl which contains limestone with fine and homogenous grain size (Fig. 2). The main point is that the cohesion of such material is low, and therefore this material is erodible. It is observed that all the materials are Pabdeh Gurpi formation which is an impermeable formation with very low cohesion. Marlstone is the typical rock of the Pabdeh Gurpi formation.
